LOC PRELIMINARY WALKOVER SURVEY RECORD SHEET
MOAI ON THE ARA MOAI

Moai no: AMS 102	Site Name: Ams	Associated Feature Nos: NONE		
Previously noted (tick) <input checked="" type="checkbox"/>	Atlas: LR-117	Hunt:	Shepardson:	Other:
Easting: 0669451		Northing: 6998251		
Statue height: 7.9 m		Statue width (across girth): 2.2 m	Statue thickness (from back to front at girth): >>1.2 m	
Photo Nos (yes/no):				
Land use: scrub		Physical relationships: none		
Position of statue(tick):		Supine	Prone <input checked="" type="checkbox"/>	On left side
Description/interpretation: WHOLE MEDIUM SIZED MOAI WITH HEAD POINTING DOWN SLOPE AWAY FROM RANO RAKAU DEEPLY BURIED AT HEAD END.				
Orientation of long axis of statue: SW SUN NE		Declination of long axis of statue: 10% Head on down slope	Alignment with Ara Moai: parallel with path	
Direction of geological bedding with relation to the statue's longitudinal axis (tick) <input checked="" type="checkbox"/>	Parallel	Horizontal	At angle <input checked="" type="checkbox"/>

Date: 23/JAN/13	Initials: MST SH RW MST FP			
Page 1 of 2

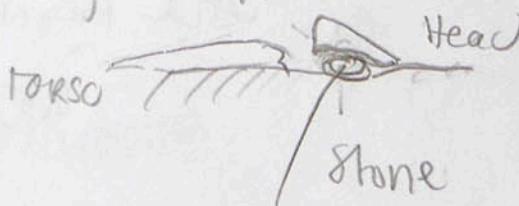
* broken at neck + tilting in opposite directions
parts (head + torso)
